Manhole Inspection Summary

Manhole # S17EE2108MH

Location Address: **1816 KELLY AVE**

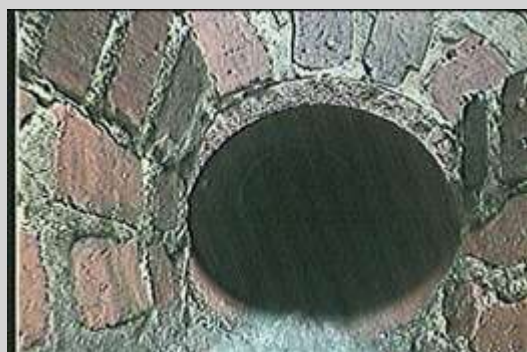
Pipe Out @ 12 O'Clock

8 in. Circular Gravity Sewer

Rod and Bar (Angled)

Pipe Material: **Clay** ☐ Pipe Lined

Infiltration: **None** Pipe Seal Cond: **Unknown**
